Portage Creek Sediment Remediation Project Kalamazoo, Michigan

Pre-Sediment Removal Structure Feature Assessment
Removal Areas SA3-A, SA3-B and SA3-Access

**FLEIS & VANDENBRINK
ENGINEERING, INC.**

August, 2012

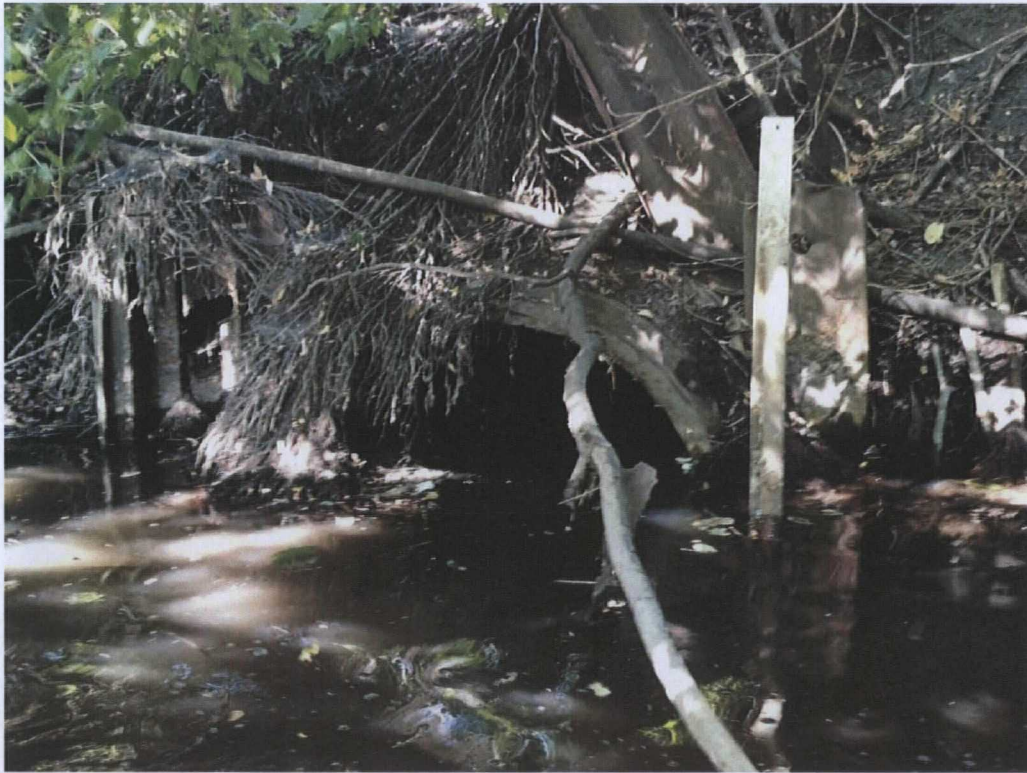
Concrete outlet in the southwest with failed sheet pile headwall

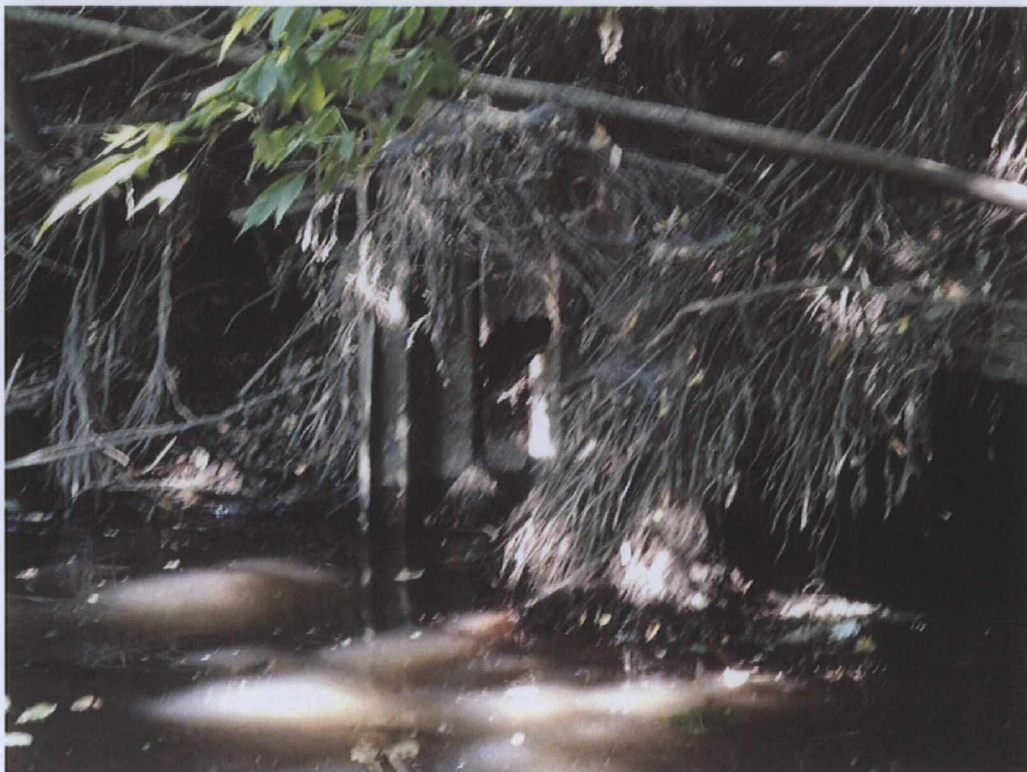
Failed sheet pile in the southwest

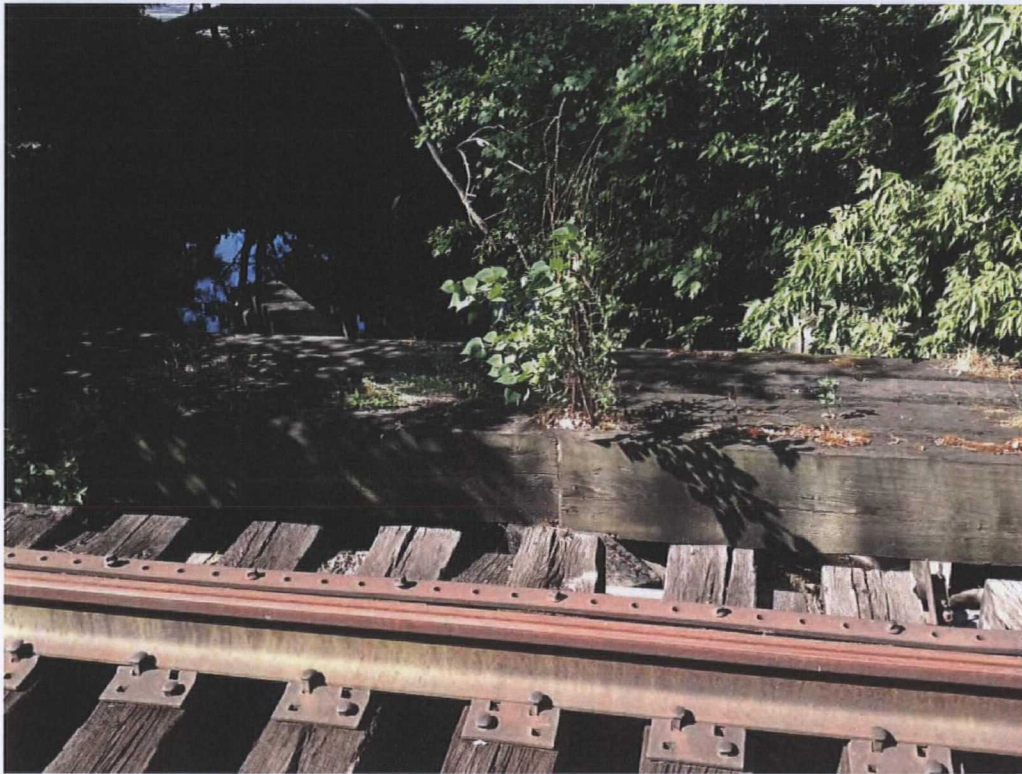
Vegetation growth in timber curb

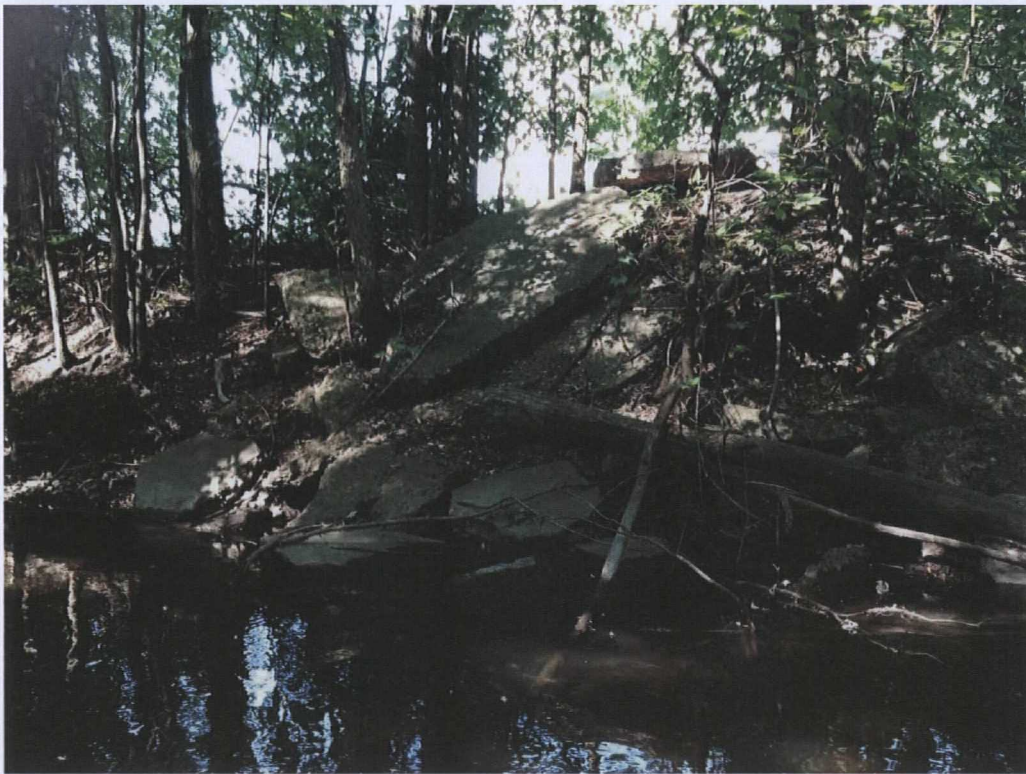
View of the structure from the channel

- The slabs should be removed and replaced as required to facilitate sediment removal.

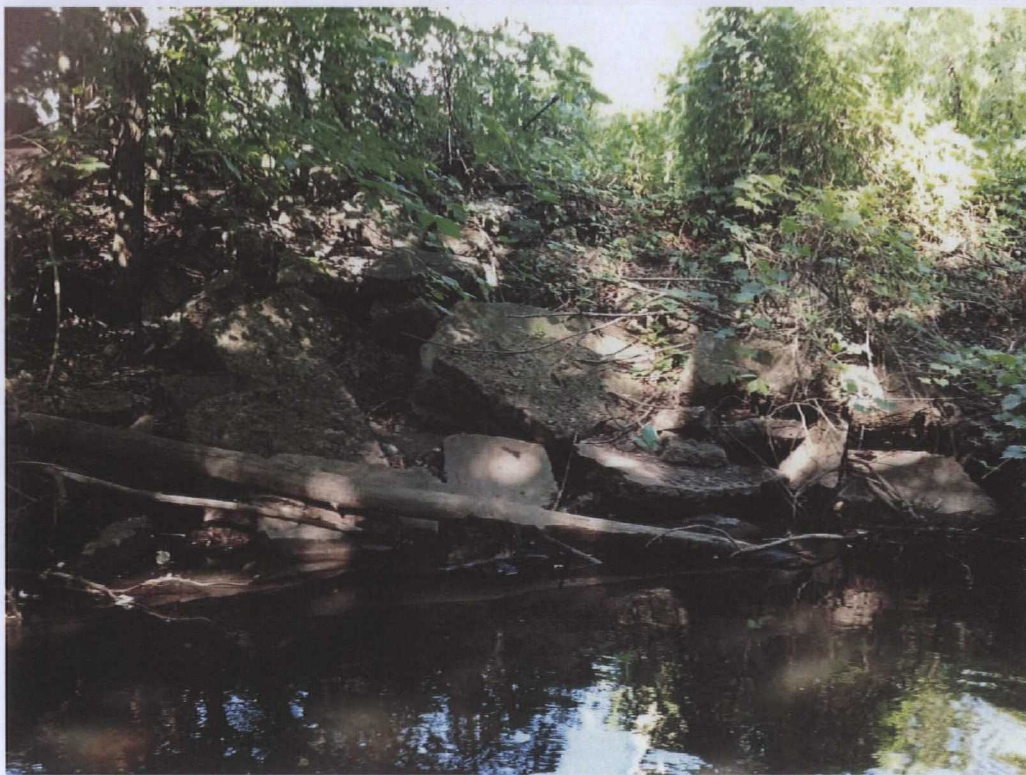
- The concrete slabs have moderate undermining along the waterline.
- A number of slabs have settled into the channel.

Undermined slabs along the waterline

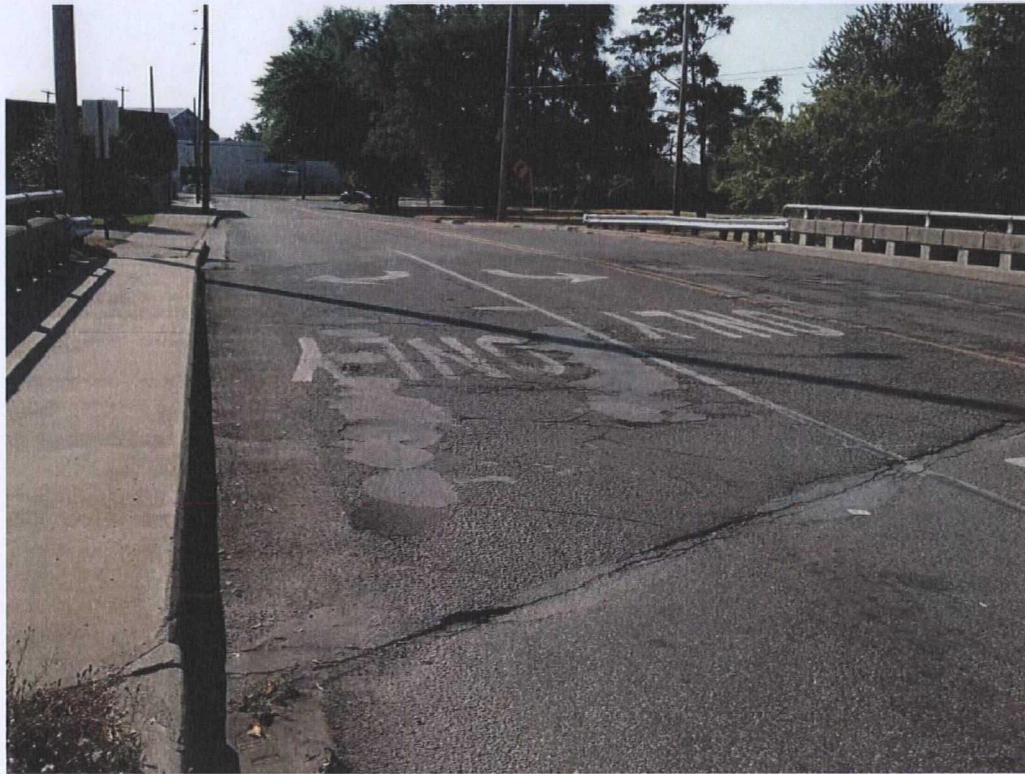
View of structure from the approach area

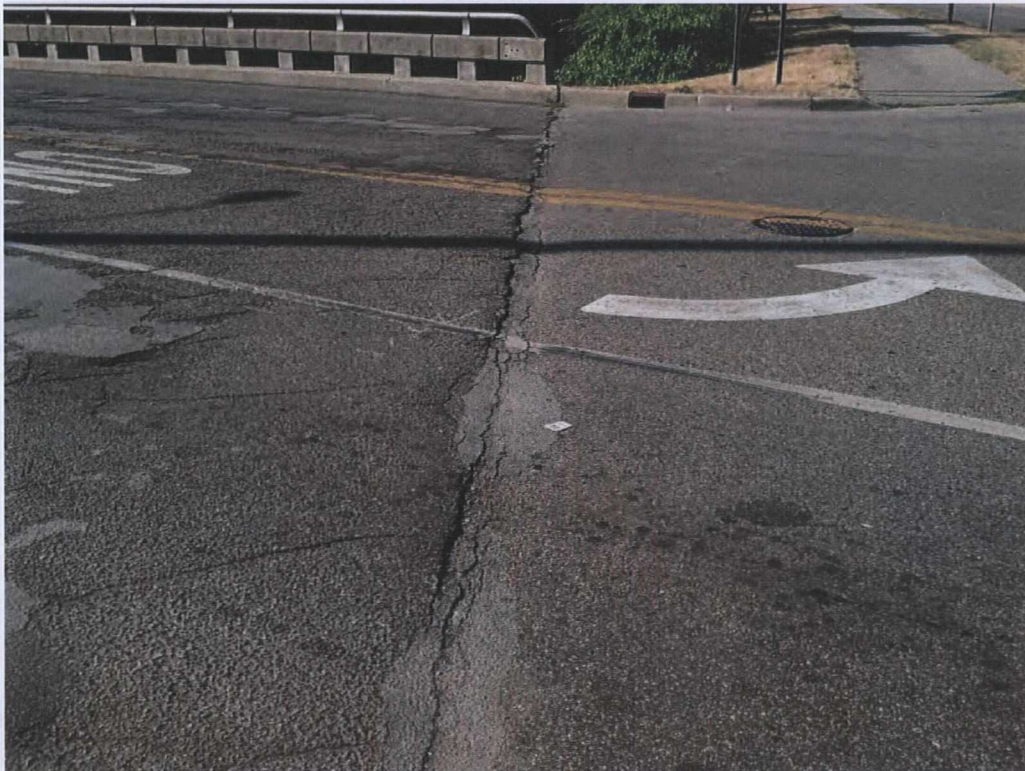
Cracking and cold patch along west reference line

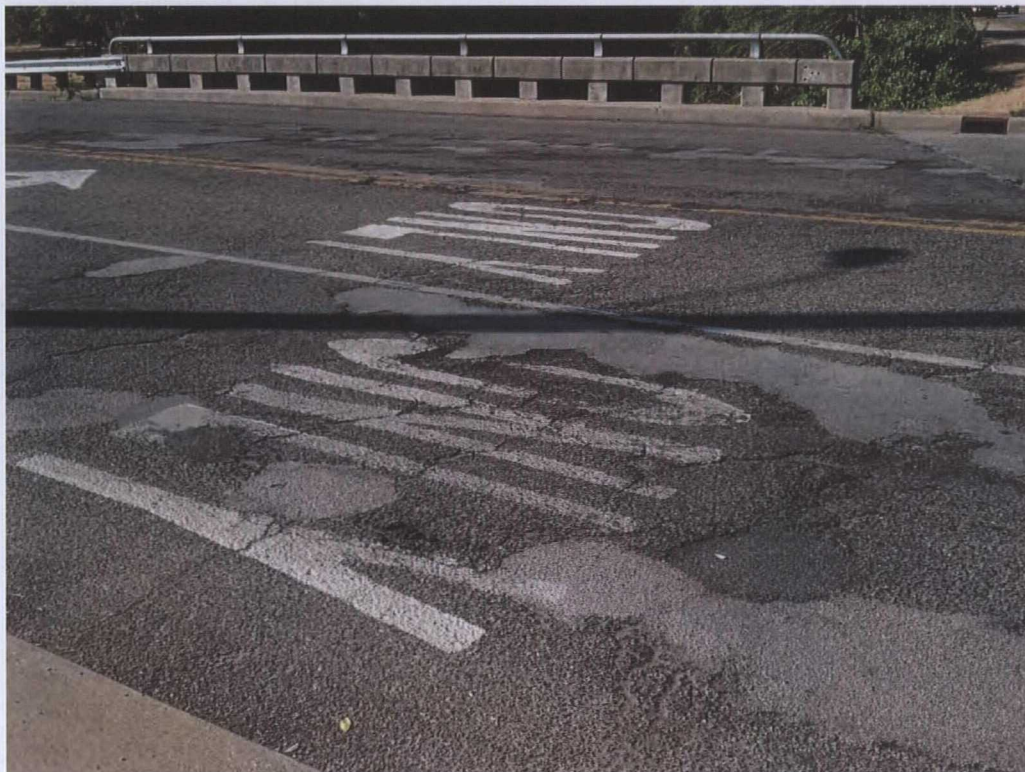
Spalling and cold patch in asphalt wearing surface

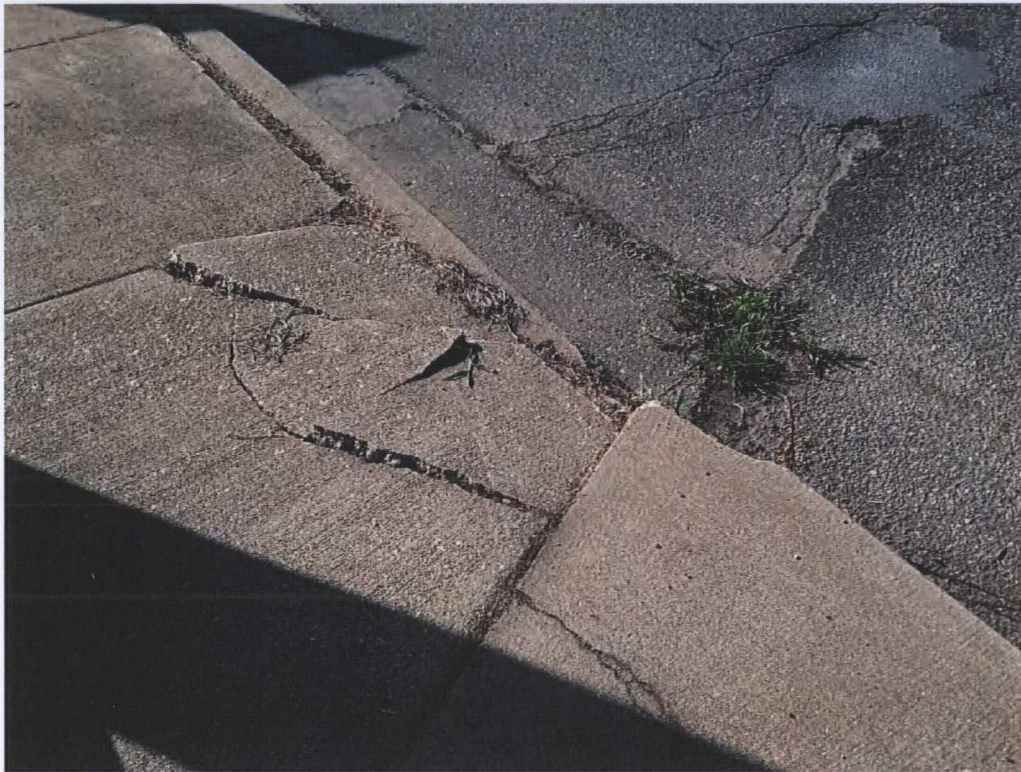
Cracking and spalling of approach sidewalk

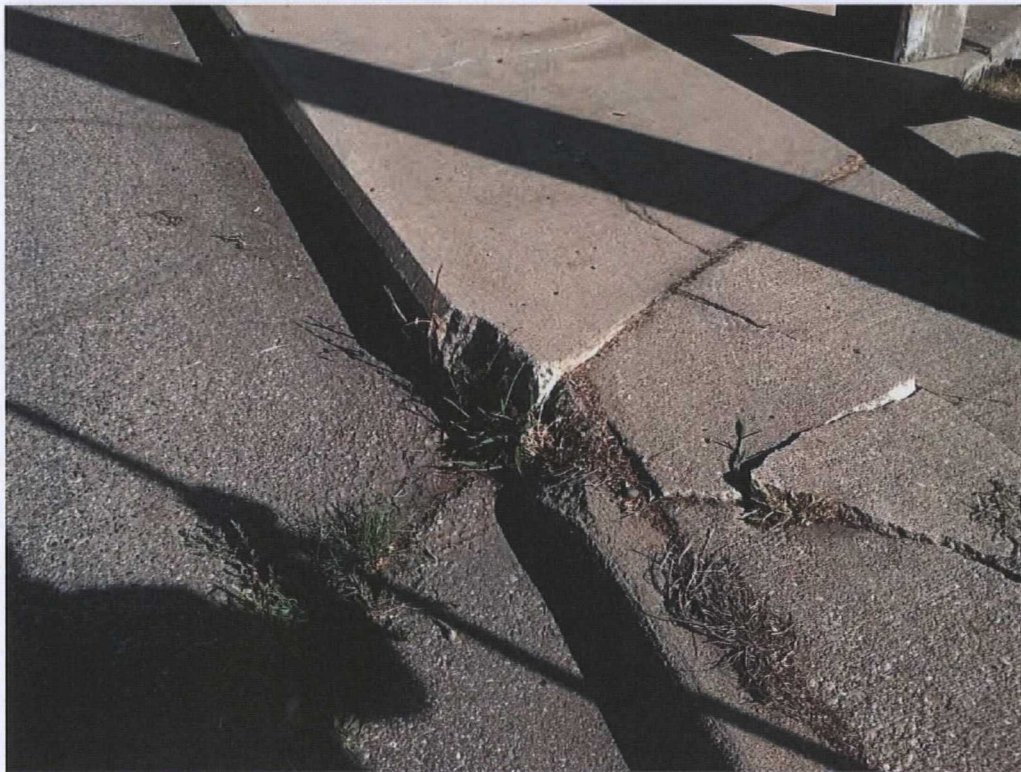
Corner spalling on curb and sidewalk in northeast

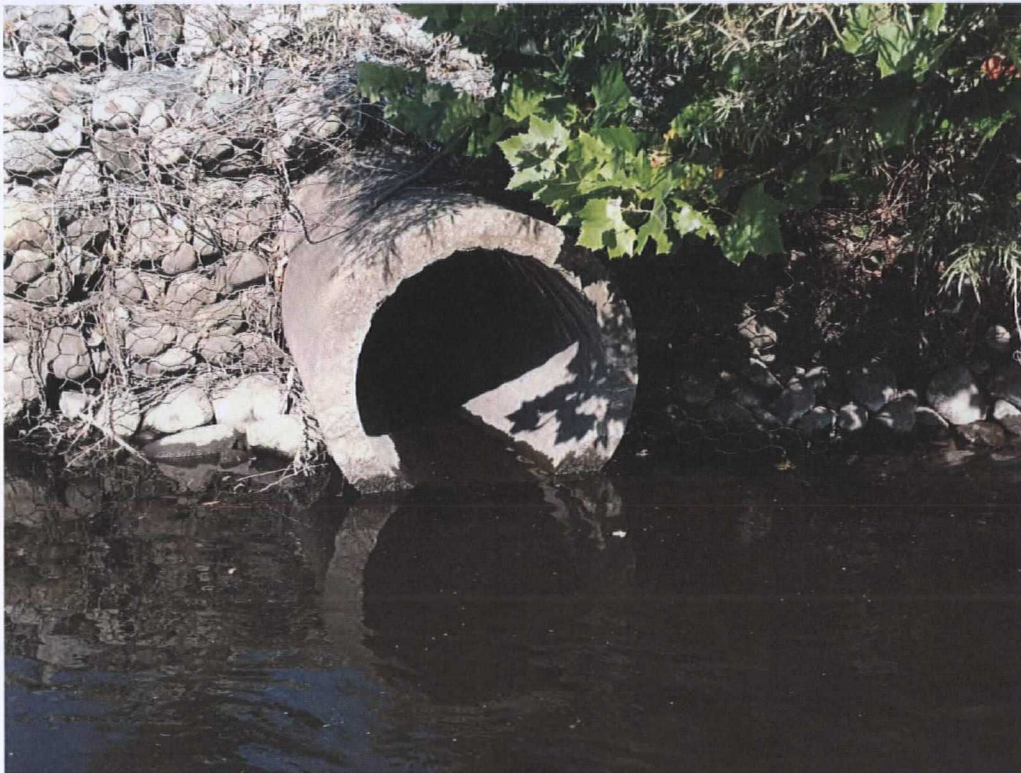
Outlet viewed from the channel

- If a cofferdam is required for dewatering, it should be installed with a minimum 2' clearance to the outlet to avoid adversely impacting it. It will be difficult to install a sheet pile cofferdam against the gabion baskets without damaging them. Therefore sand bags are recommended either against the baskets or for the entire cofferdam.

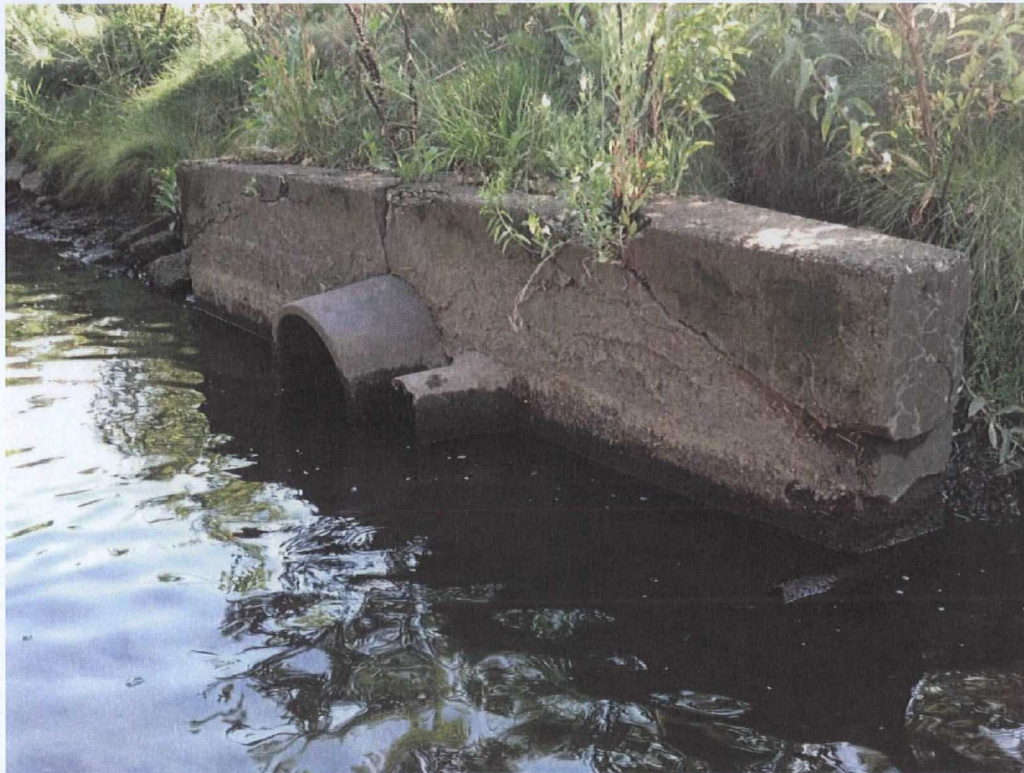
- The bank is severely eroded around the structure, exposing the clay pipes behind the headwall.
- The concrete headwall has moderate to severe cracking.

View of structure from south channel showing cracking and spalling of headwall

- If a cofferdam is required for dewatering, it should be installed with a minimum 4' clearance to the headwall to avoid adversely impacting it. We recommend contacting the property owner for permission to remove the headwall and cut off the outlets at the bank.

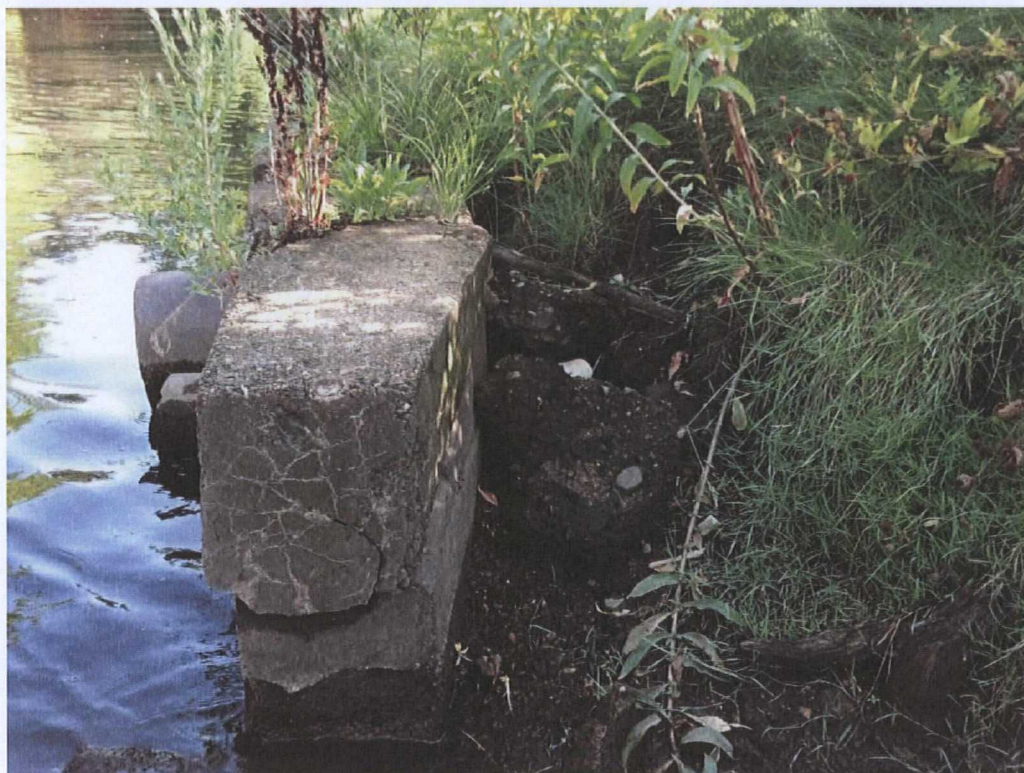
Severe bank erosion behind headwall

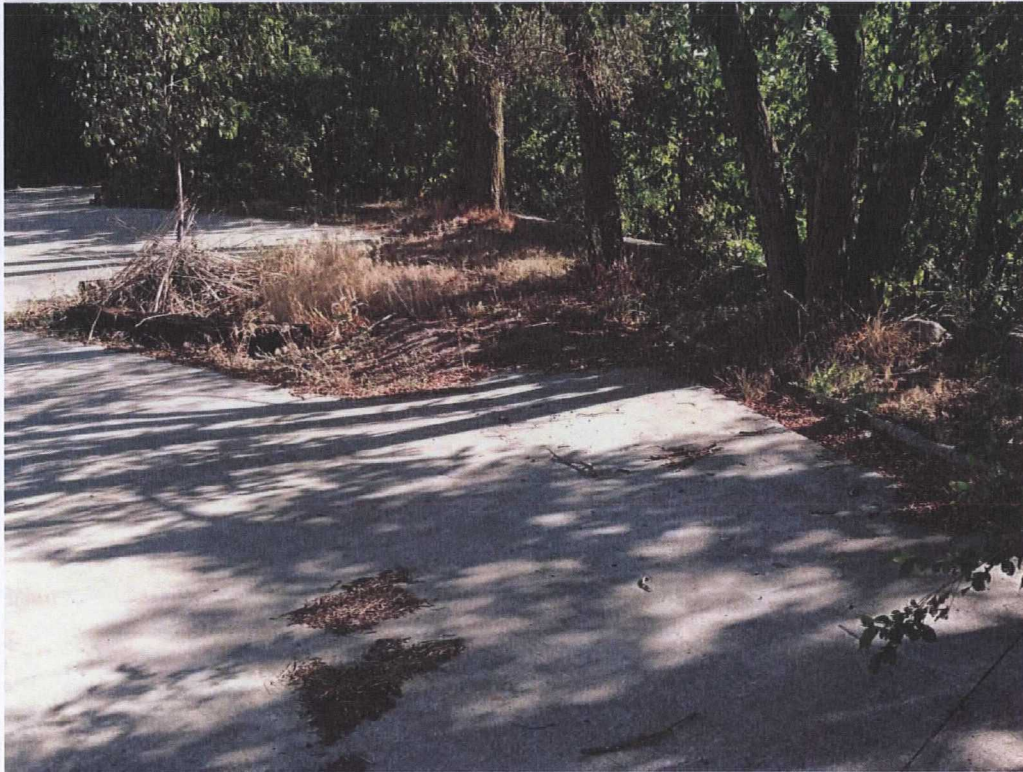
View of parking lot from the south

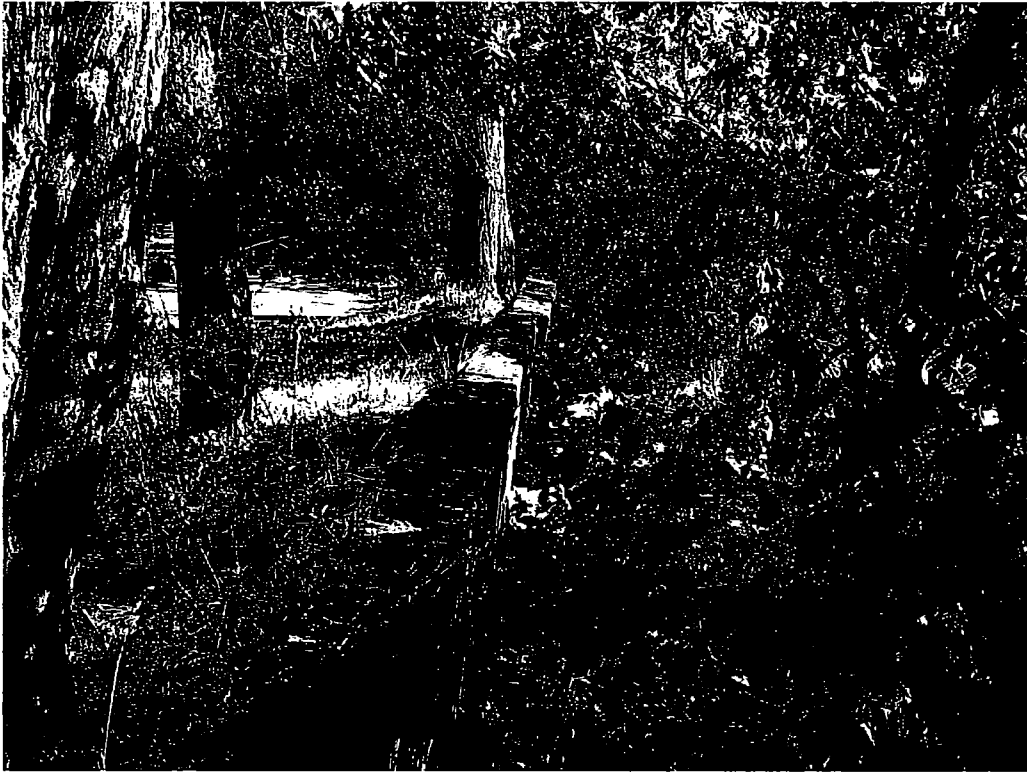
- The concrete retaining wall is in poor condition, leaning in several locations. There are several severe to critical vertical cracks in the wall. Growth of a large tree behind the wall has caused ~2" offset at one of the cracks.
- The parking lot is newer concrete paving.

Critical vertical crack and leaning section of retaining wall at tree growth

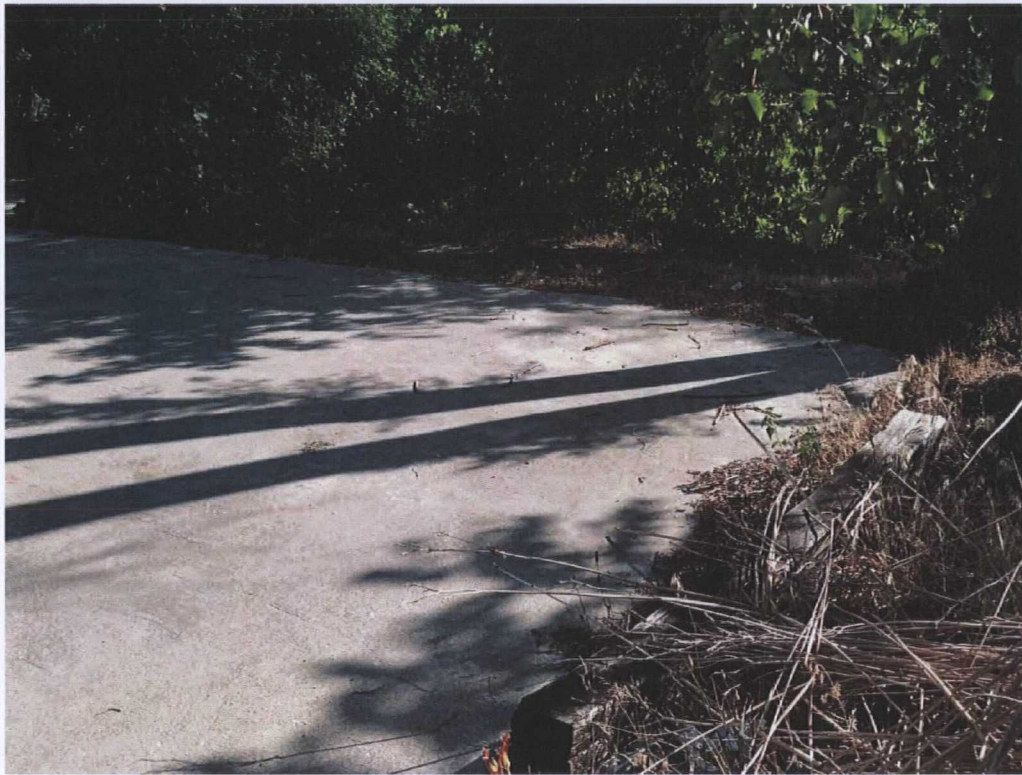
View of parking lot along top of bank

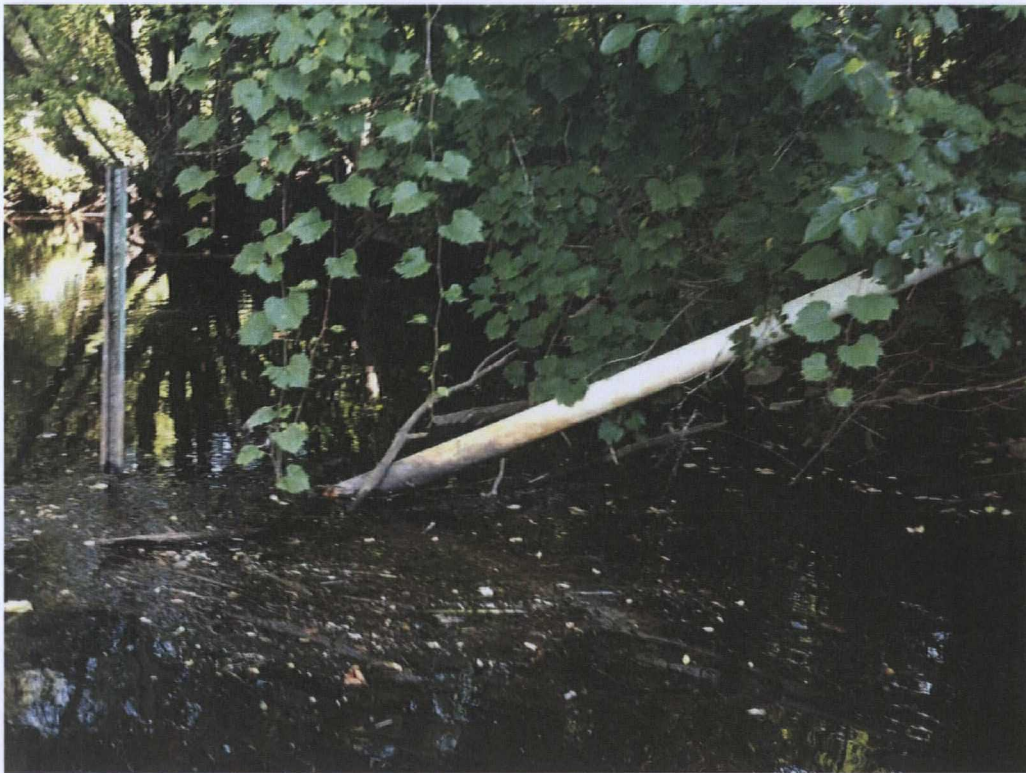
- There is moderate corrosion on the steel post in the channel.
- The PVC sampling tube is not connected to the unit at the top of the bank.

View of PVC sampling tube from south channel

- Coordinate with the City to remove and replace the structure if required for sediment removal.
- Identify the structure to operators and drivers with construction fencing or similar during the work.

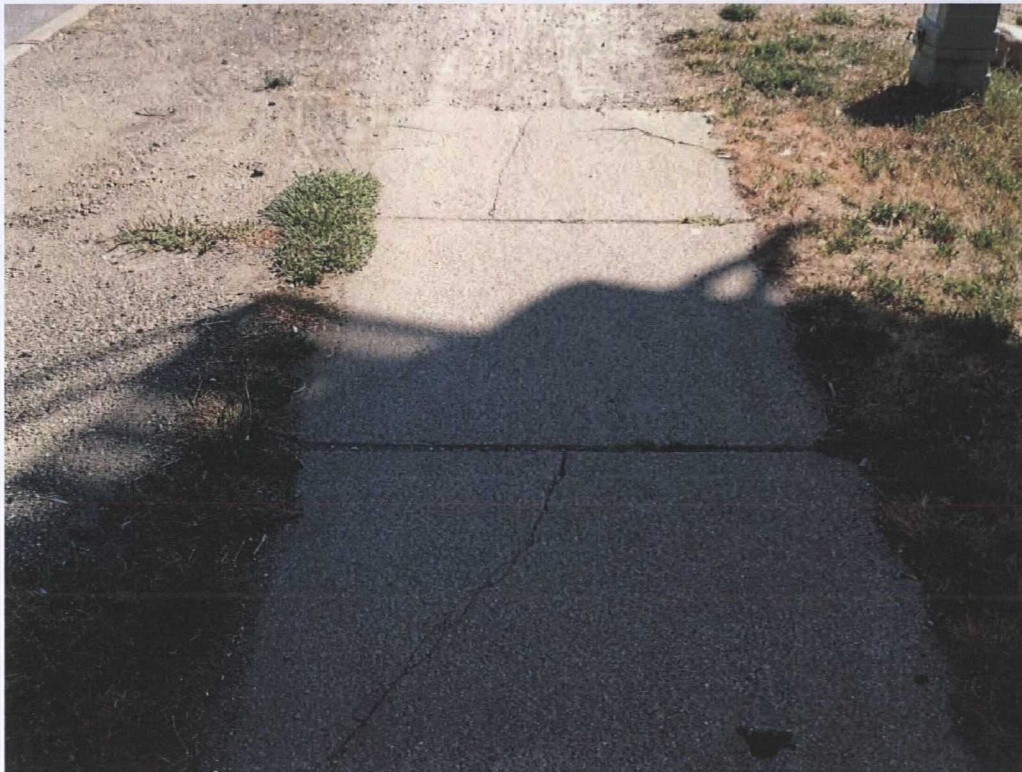
- The east flag and 3rd from east flag of concrete have moderate cracking.

Cracking in the east flag and 3rd from east

- The existing sidewalk is likely not intended for trucking loads and will likely crack and spall during the work. Damaged sections should be removed and replaced in kind.

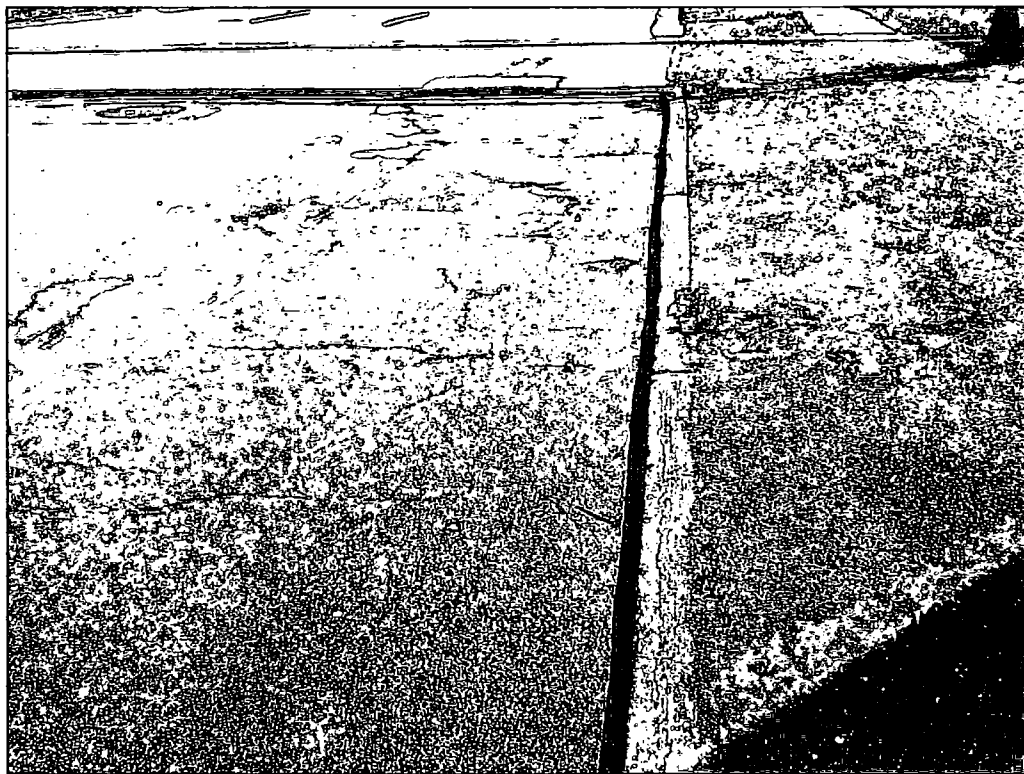
Block cracking and cold patch in asphalt pavement

- Repair asphalt pavement and/or concrete curb and gutter if damaged during the work.
